**SAFE
LOADING
PASS
SCHEME**

Liquid fuels Inspection Manual

The following text is reproduced with permission from the Energy Institute's publication: Petroleum road tankers: Recommendations for a standard method of inspection for a safe loading pass (first edition).

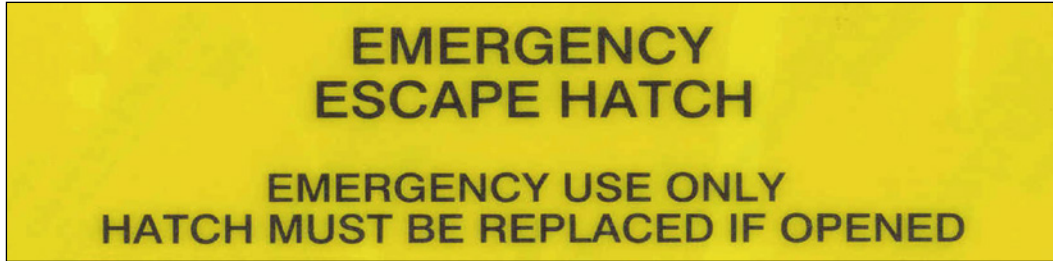
Figure 1

Roof hatch designed for emergency egress, showing information labels and sealing arrangement

Requirement	Method of inspection	Reason for failure
<p>If fitted, the roof hatch is:</p> <ul style="list-style-type: none"> • secured closed and unopenable, or • fitted with seals in accordance Annex A if designed to be used as an emergency exit 	Visual inspection.	<p>Roof hatch is:</p> <ul style="list-style-type: none"> • not secured, or • openable, or • not sealed in accordance with requirements in Annex A

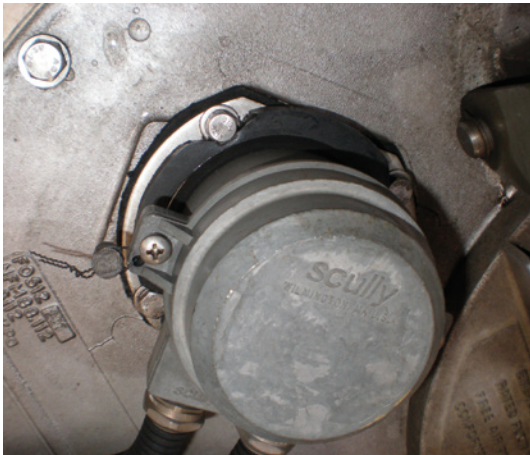
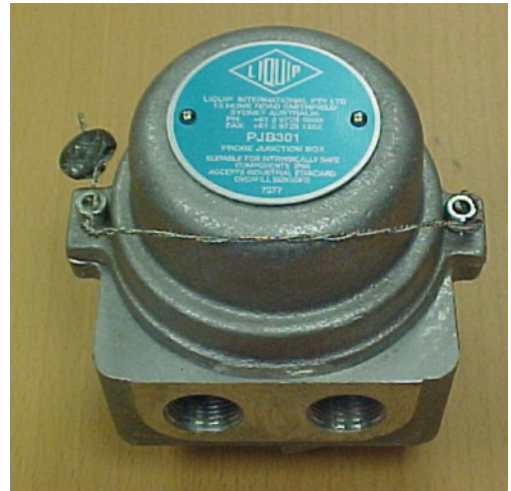
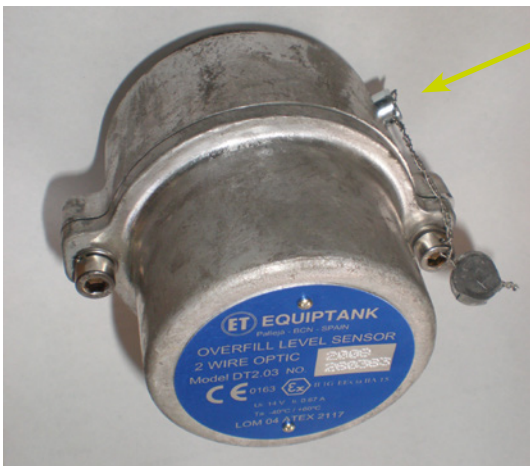
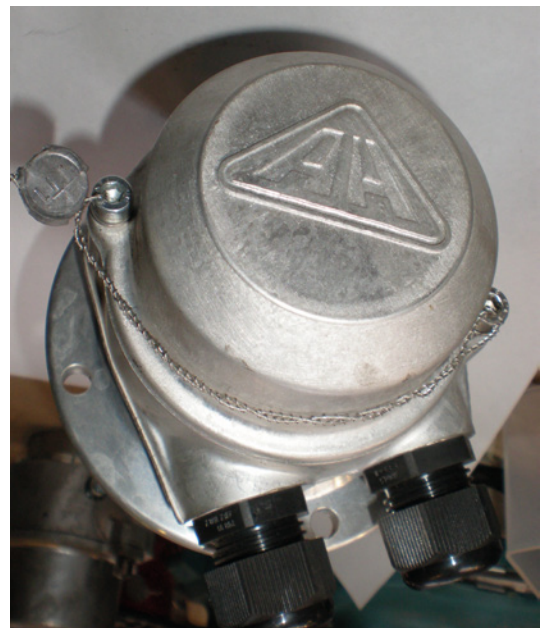
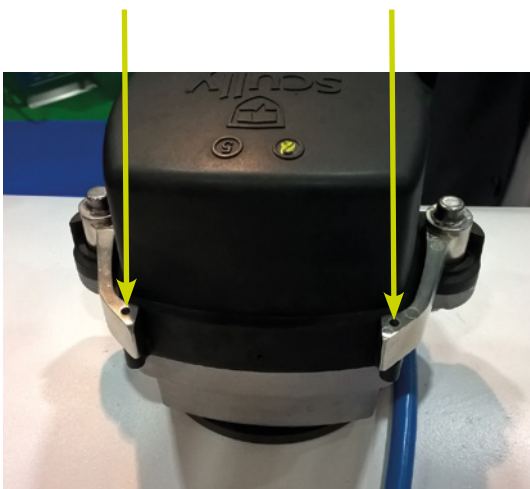
Annex F

(See section 12.5 – Overfill prevention system sensors – wiring and sealing of sensor housing cap/adjustment screw)

Note: where the adjustment screw is not mounted under the cap, it must be wired and sealed to a cap screw.

Note: cap securing handles must be wired and sealed closed

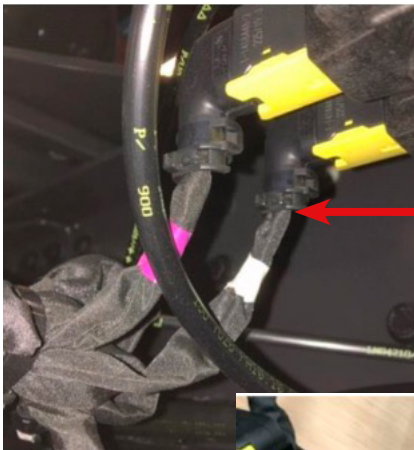
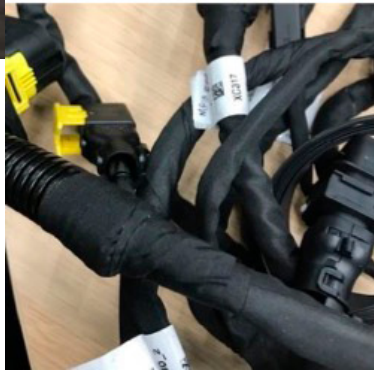
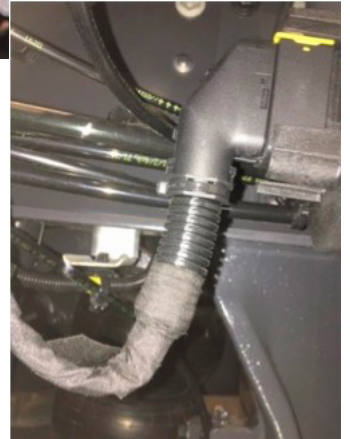
Annex H

See section 5 – Electrical system (external to the cab) – secondary insulation type only applicable for Volvo Group vehicles manufactured after 1 June 2019
